City of Baltimore Wet Weather Consent Decree Smoke and Dyed Water Testing Form		Page 1 of 3
Sewershed : Gwynn Falls	Company : <u>URS</u>	Date: 09/24/2008
Test to be Performed : Smoke : X Dyed Water :	Ground Condition : Dry : X Damp : Wet :	Supervisor : Ryan Lamont
Manhole ID: S03QQ 003MH	Test ID: S1032-022039	Notifications (Residents, Fire, 311) : Yes

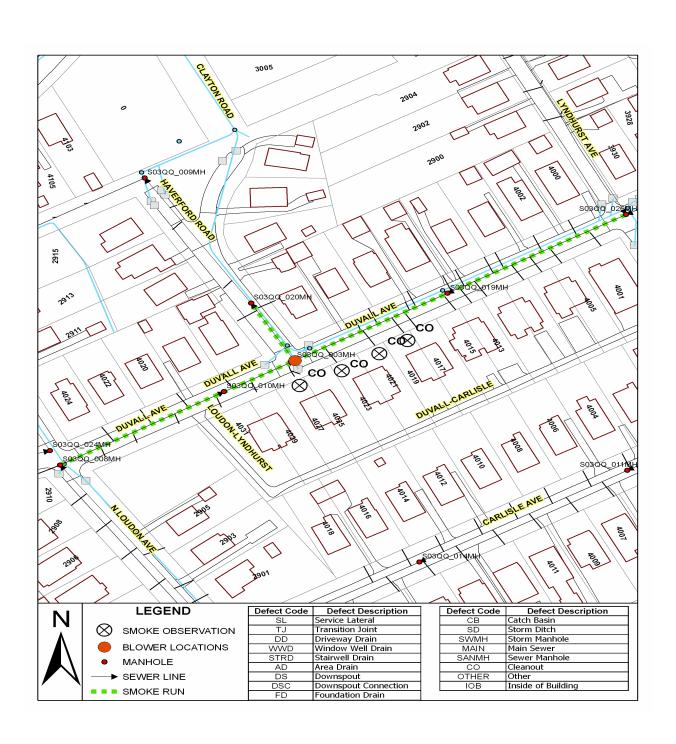
Field Sketch : (Show All Manholes with Numbers, Blower Placement Location, Sandbag or Isolation Locations, Street Names, Building Addresses and Locations, Defect Locations and Photograph Numbers)
